\$ 1,000,000 savings on a primary crusher

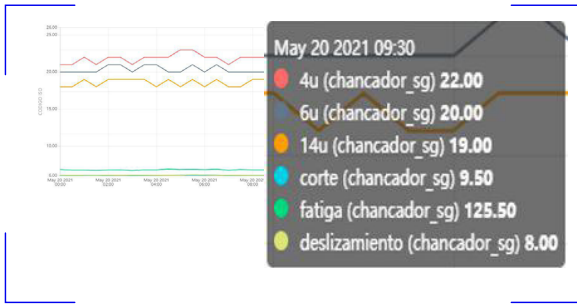
May 20th, 2021

“Normality line” of primary crusher operation was set to an ISO code 22/20/19, as seen in the box, the average data before the failure began.

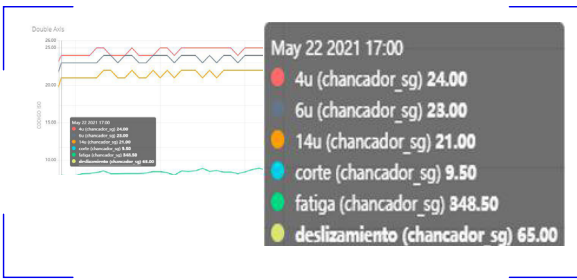
May 22nd, 2021

At the precise moment when the values showed a notable deviation, increasing beyond the normal ISO code (24/23/21), an increase in sliding wear was detected. *

Armed with this information and mindful of the previous catastrophic bushing failure, the operator conducted on-site inspections, leading to the discovery of a fault in one of the bushings.

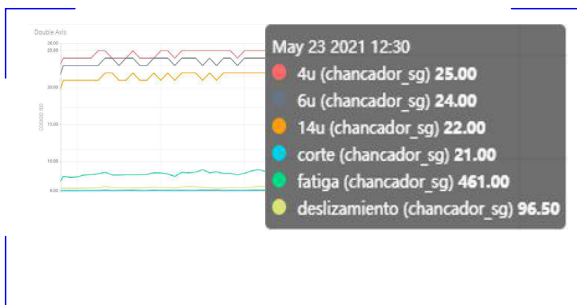
May 23th, 2021

The graph shows a sustained upward trend in the ISO code (25/24/22). Similarly, the classification of particulate matter indicates a continuous increase in cutting and sliding particles.

To stabilize the crusher’s performance, several corrective actions were implemented, including partial lubricant changes, enhanced lubrication practices (such as lifting and balancing the bushing with additional oil supply), reducing the machine’s operating speed, and maintaining frequent filter replacements.

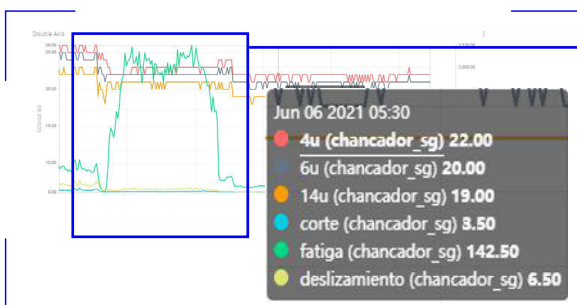
June 06th, 2021

Thanks to continuous monitoring, an issue with a bushing was detected, associated with the presence of cutting and sliding particles deviating from normal operating parameters. Without Atten[2]’s imaging technology and shape analysis, detecting this damage in time would have been impossible or very difficult. The ability to provide reliable measurement results even with high oil viscosity and strong bubble formation in lower ISO classes, compared to conventional particle counters, is another key advantage that enables early damage detection under harsh conditions as given here with this particular crusher.

Prompt actions were taken to rectify the situation, allowing production to proceed as planned. On June 6th, 2021, corrective measures were implemented during the scheduled plant shutdown, replacing the bushing. After the crusher’s startup process, it returned to its established ‘normal line’ of operation, indicated by the ISO code (22/20/19). During the monitoring period, a bell-shaped curve in fatigue particles was noted, a typical phenomenon linked to the machine’s startup phase.
