## Yellotec Vibration

## Over US\$48M value realised from Online Vibration Monitoring on a Colliery

**Site:** Colliery

**Machine:** VSD Drive motor on Incline Conveyor

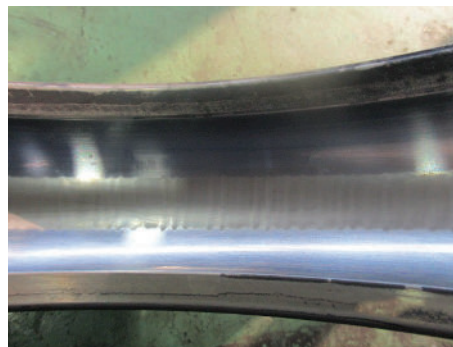
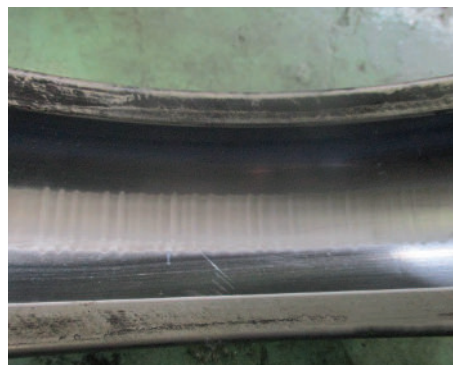
Bearing Defect caused by Electrical Fluting

Alarm due to high vibration was observed on the NDE Motor Bearing. Harmonics of Outer Race Defect frequency at 177,6 Hz with side bands spaced at FTF (cage frequency) 10,67 Hz evident in the demodulation and acceleration spectral data comparisons. Gradual increase in spectral band trends noted. Also noted was a high frequency vibration in the region of 5 kHz with side bands spaced at 2X LF, confirming that the Motor is running on a VSD and suspected fluting as a secondary effect.

The NDE bearing was cleaned and opened for inspection. The bearing outer race show clear signs of damage due to electrical fluting. The NDE bearing defect identified by Condition Monitoring was a result of electrical discharge through the NDE bearing. The erosion of the raceway resulted in contamination of the grease. Continued operation with this condition would have resulted in premature failure.

Initially it was recommended to ensure adequate bearing lubrication; however, no improvement was noted and as the defect progressed it was recommended to replace the Motor. The motor was then sent off site for inspection and repair.

Specific attention should be paid on drives that are equipped with Variable Speed Drives (VSD's), this includes Motor shaft grounding brushes that should be in place to discharge electrical currents to prevent secondary damage on motor bearings.
