CASE STUDY: Electrical Signature Analysis for Power Plant Pump Performance Assessment

Performing the Electrical Signature Analysis

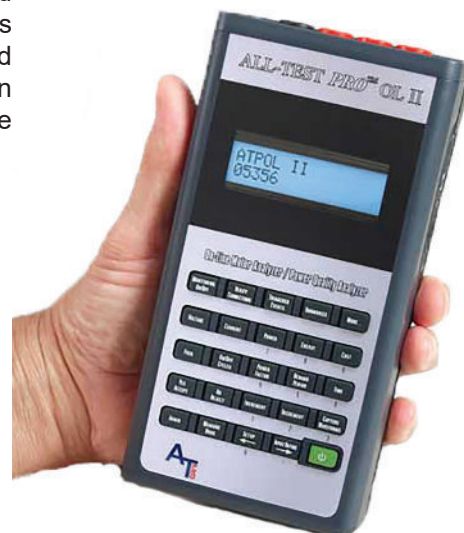
“The ATPOL II™ collected & transmitted the data via Bluetooth while Dunn & the Maintenance team were positioned a safe distance away from the high voltage equipment.”

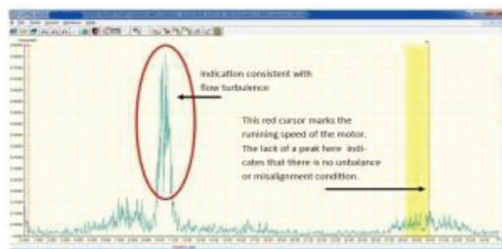
This is an FFT of the demodulated current spectrum where the pulsation is shown as a broad peak around 10 HZ. This is a typical indication of turbulent flow.

- The motor was electrically perfect with balanced current and voltage, and 90+ power factor.
- The motor and pump were mechanically excellent with no indications of misalignment or unbalance, bearing issues, rotor, or stator issues.
- Tests showed a significant fluctuation in the current draw, pulsing at about 10 Hz. Dunn and the team collectively determined that this was caused by non-laminar flow, or **turbulence in the system**.
