## Yellotec Vibration

## Over US\$48M value realised from Online Vibration Monitoring on a Colliery

**Site:** Colliery

**Machine:** VSD Drive motor on Incline Conveyor

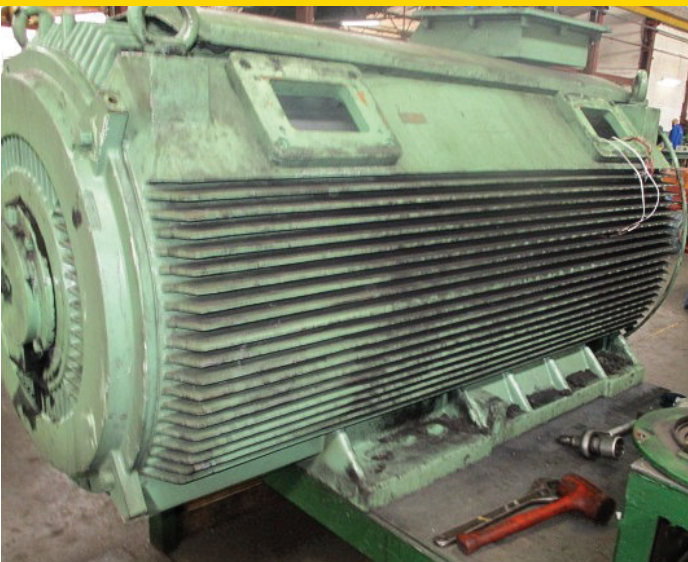
Bearing Defect caused by Electrical Fluting

Alarm due to high vibration was observed on the NDE Motor Bearing. Harmonics of Outer Race Defect frequency at 177,6 Hz with side bands spaced at FTF (cage frequency) 10,67 Hz evident in the demodulation and acceleration spectral data comparisons. Gradual increase in spectral band trends noted. Also noted was a high frequency vibration in the region of 5 kHz with side bands spaced at 2X LF, confirming that the Motor is running on a VSD and suspected fluting as a secondary effect.

The NDE bearing was cleaned and opened for inspection. The bearing outer race show clear signs of damage due to electrical fluting. The NDE bearing defect identified by Condition Monitoring was a result of electrical discharge through the NDE bearing. The erosion of the raceway resulted in contamination of the grease. Continued operation with this condition would have resulted in premature failure.

Initially it was recommended to ensure adequate bearing lubrication; however, no improvement was noted and as the defect progressed it was recommended to replace the Motor. The motor was then sent off site for inspection and repair.

Specific attention should be paid on drives that are equipped with Variable Speed Drives (VSD's), this includes Motor shaft grounding brushes that should be in place to discharge electrical currents to prevent secondary damage on motor bearings.
